Possibility of Increasing the Surface Contact Fatigue of the Gearing by Laser Hardening

Abstract: An investigation was made to determine the causes of surface contact fatigue failure of a case hardened driver pinion located in the intermediate shaft of a reducer gearbox used in a sugar and alcohol mill. The examination of the component revealed the presence of a cemented layer substantially thicker than that generally specified for pinions devised for this application. This, associated with the massive presence of brittle threadlike carbon-rich cementite phase (Fe_3C) in prior austenite grain boundaries of the pinion teeth, favored surface crack nucleation and propagation during cyclic loading, leading to spallation of the contact surface with the counterpart gear, which impaired the system's operation. Poor carburization practice was discovered as the root cause of the mechanical failure, thus demanding the implementation of a new manufacturing route to avoid problems in similar load-bearing rotating components.

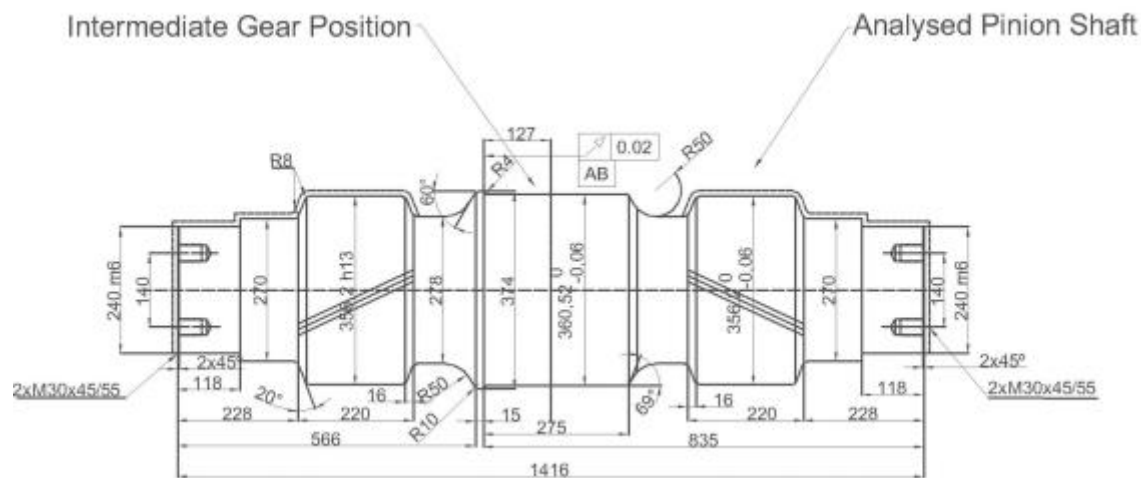
Fig.1: Draft of the intermediate reducer shaft, where the fractured pinion shaft is indicated by an arrow. The location of the corresponding idler (intermediate) gear is also arrowed.³

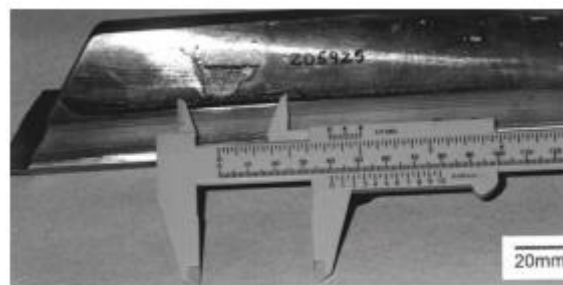
Fig.2: Representative case of a badly damaged pinion tooth surface.

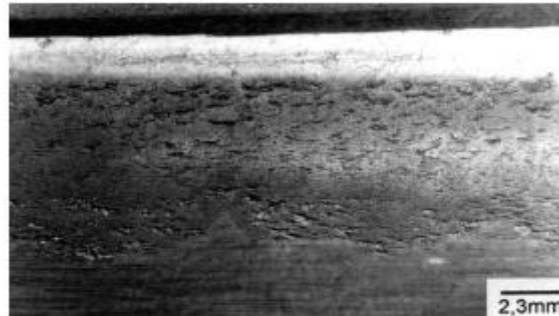
Figure 3 depicts the contact line of the counterpart gear tooth, clearly showing the presence of pits. This is normally the first stage of RSCF under relatively low applied stresses, and is corroborated here by the absence of noticeable plastic deformation of the inspected surface. In fact, in this position (contact or pitch line) the maximum bearing (compression) stresses develop between the pinion and its counterpart gear surfaces. On the other hand, the peak location of subsurface stress resulting from the sum of rolling and sliding stresses occurs elsewhere below the surface. Figures 4a and 4b show the so-called cyclone pattern shown in Figure 2, developed under surface contact fatigue in the pinion pitch line, which is created by continuous and extensive fragmentation of the case hardened layer of the pinion tooth in the rolling direction.

Fig.3: Detailed view of the contact line and neighboring regions of counterpart bigger gear viewed with a binocular stereoscope (microscopic pitting).

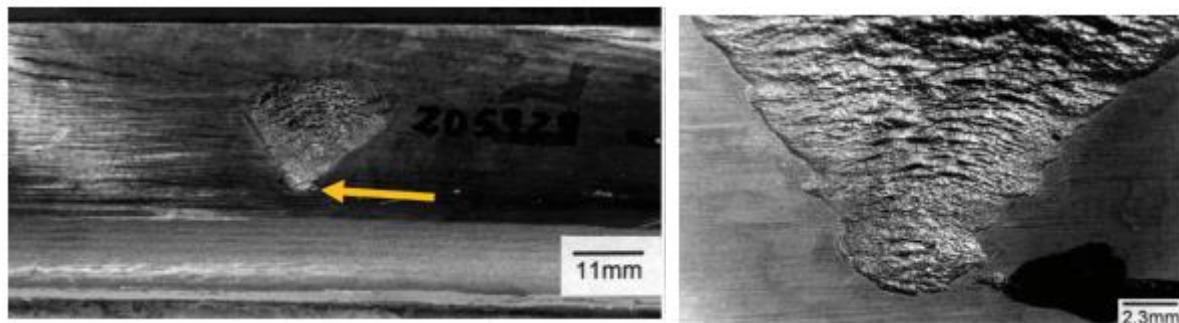
Fig.4: Surface contact fatigue damage of the cemented and subsequently Q&T SAE 8620 steel pinion tooth flank: Typical cyclone morphology, with the likely initiation site indicated by an arrow; Detailed view of the formed cavity (classified as severe spalling) seen under a binocular stereoscope

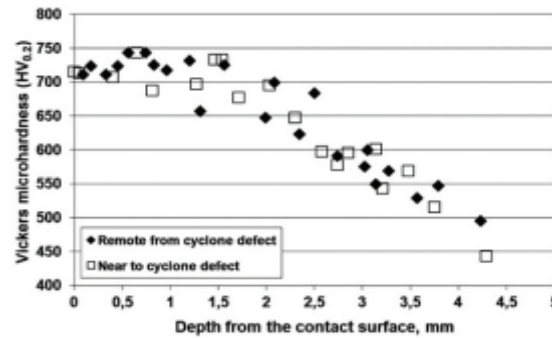
Rockwell macrohardness measurements of the pinion tooth core indicated values ranging from 34.0 to 42.7 HRC, which are very close to the 35.0-43.0 HRC specified in the design stage. Microhardness values are plotted in Figure 5, where the data points indicate a hardened case depth of 3.2 to 3.5 mm, assuming that the nominal thickness of the cemented layer

corresponds to the position where a value of 550 HV0.2 is reached from the top layer surface after the Q&T heat treatment, according to the DIN 50190 standard. Compared to the typical target value of 2.6 mm specified for this pinion shaft size, it can be concluded that the thickness of the hardened case exceeded 0.6-1.1 mm.

Fig.5: HV0.2 microhardness profiles of the case hardened layer in the wake of two distinct linear paths of a pinion shaft tooth flank containing a cyclone type defect.

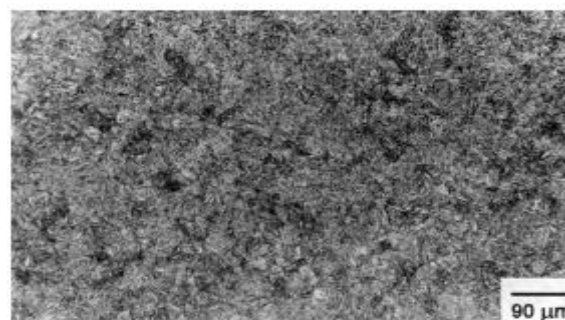
Fig.6: Typical microstructure of the pinion tooth core. Etched with Nital 2%.

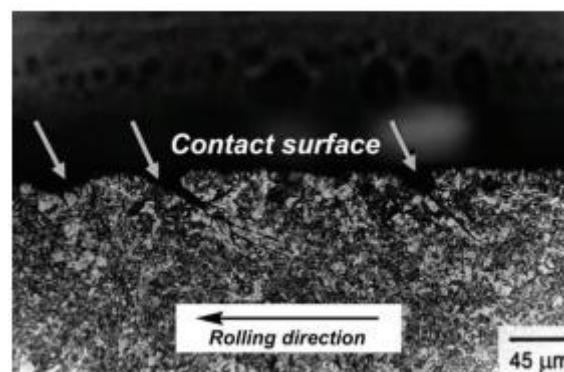
Fig.7: Cross-section view of a pinion tooth showing several pits (indicated by arrows) from which fatigue cracks branch out towards the bulk microstructure during periodic contact with the counterpart gear tooth surface. Etched with Nital 2%.

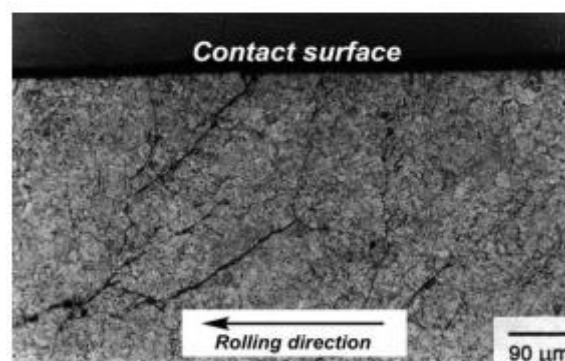
the counterpart bulkier gear (keeping in mind that the view planes of Figures 3 and 7 are orthogonal each other). Figure 8 shows several subsurface cracks emerging from the pinion tooth surface, causing the release of fragments of the hardened case thus favoring the generation of cyclone type damage, as already depicted in both the Figures 2 and 4. Furthermore, it can be inferred that the fragments detached from the wear surface are the net result of

Fig.8: Emerging cracks in a slightly worn portion of the contact surface in the case hardened pinion tooth. Etched with Nital 2%.

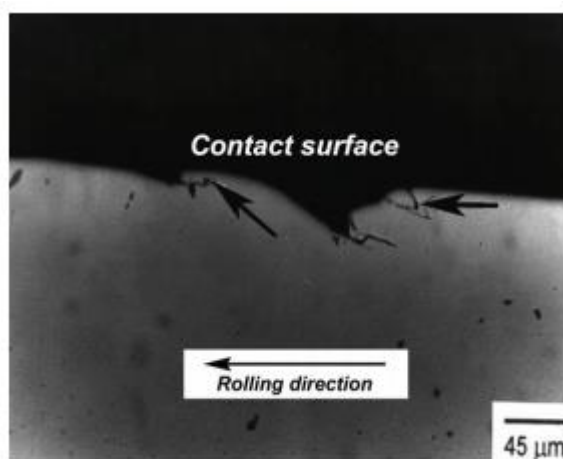
grains or grain agglomerates are pulled out from the surface, generating pits and wear debris. Once pits have been formed, the pitting mechanism follows a geometric discontinuity that concentrates stresses, at which point nucleation and subsequent crack propagation phenomena are absolutely viable and occur readily, leading to increasingly expanding and geometrically complex damage. Furthermore, it is very important to emphasize the deleterious effect of oxides and carbides already in the stage of crack nucleation, since they are known to be brittle phases that can induce severe stress concentration. Figure 10 shows the role of the microstructure of the cemented steel layer, in terms of how the nature, content and spatial distribution of inclusions affect the removal rate of material from the pitch line in the pinion tooth. The left hand arrow shows a hard particle in the cemented layer, thus

Fig.10: Brittle particles at the surface of the cemented layer (indicated by arrows), which are about to be dislodged, resulting in pits and contact surface unevenness. No etching.

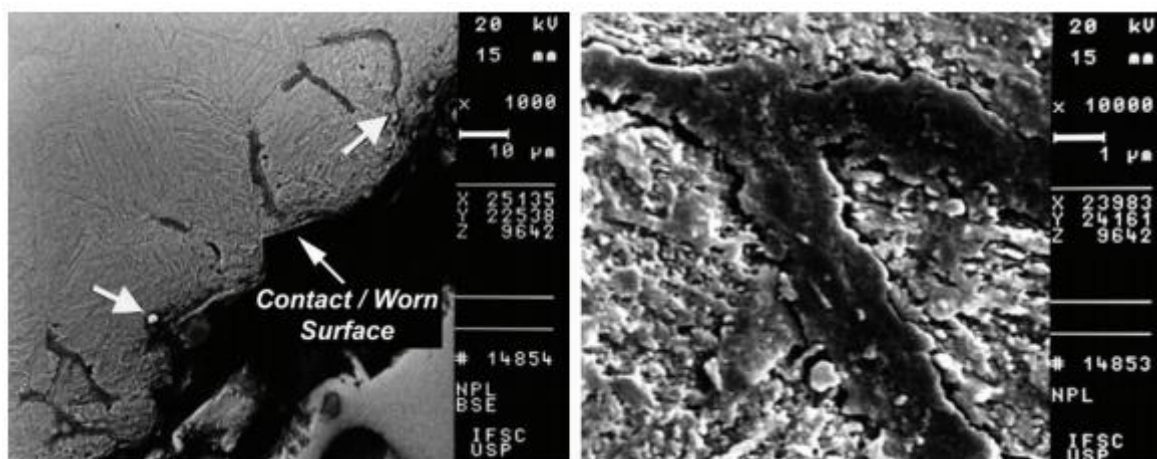
analysis To complete the identification of microconstituents at grain boundaries in the tempered martensitic microstructure at the flanks of the failed pinion tooth, a SEM analysis in backscattered electron (BSE) mode was first performed of this particular region. Figure 11a confirms the presence of a secondary phase in-between neighboring martensitic packets (i.e.,

prior austenitic grains). SEM-BSE allows phases differentiation on the basis of their distinct densities, where lighter colors refer to higher densities and vice-versa. As can be seen, the density of the vermicular phase located inside the packet or grain boundary network is much lower than that of the metallic matrix (SAE 8620 steel), thus reinforcing the hypothesis of a massive presence of cementite in that region. Figure 11b proves the existence of a continuous brittle film along the boundaries of the martensite (prior austenite) on the surface of the pinion's cemented layer. Energy dispersive X-ray microchemical analysis of intergranular and intermetallic phases seen in Figure 11 attested them as Fe_3C and CrNiMo microconstituents, respectively.

Fig.11: (a) Vermicular morphology of cementite phase at grain boundaries. The intermetallic particles indicated by arrows are much denser than those of an average steel matrix; (b) Detailed view of the continuous cementite film located at the grain boundaries. Etched with Nital 2%.
