Effect of Surface Coating on the Bonding Strength of Reinforcing Steel Bars in Concrete Structures

MN Uddin & MA Islam

^{1,2}MME Department, Bangladesh University of Engineering and Technology, Dhaka-1000, Bangladesh

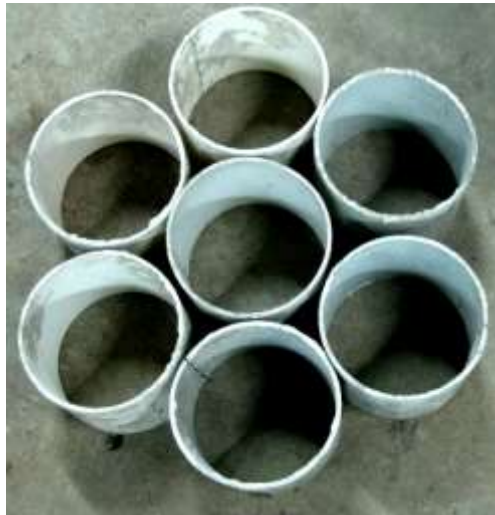
Figure 1. Photographs of plastic mould for concrete casting.

manually and they were dried properly. For epoxy resin, a hardener was used before applying for coating. Keeping one steel bar at the centre of the plastic moulds (Figure 1) of 8 inch height and 6 inch diameter concrete was cast inside the mould and it was properly compacted by pocking action.

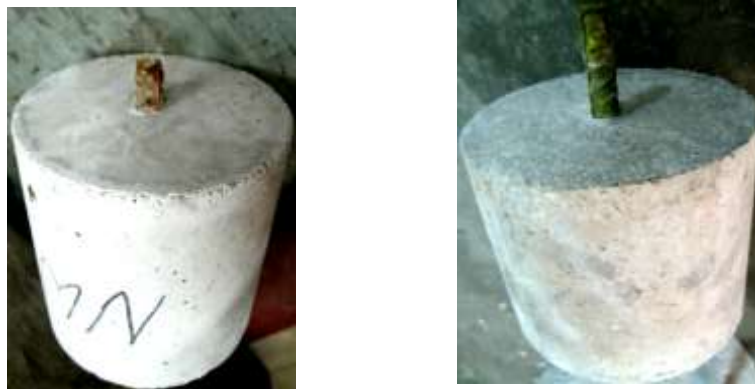
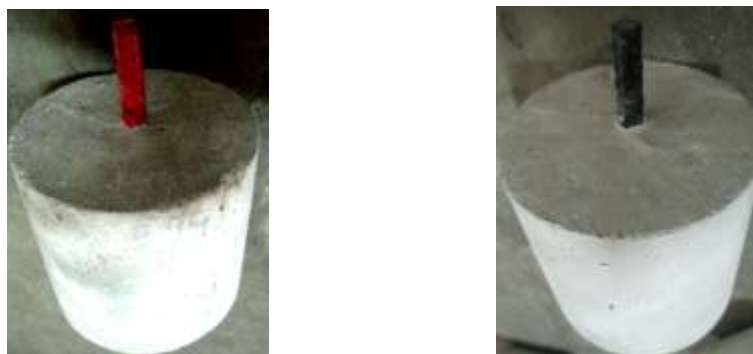
Figure 2. As-received (left) and epoxy paint coated (right) steel bars in cast concrete blocks.

The cast concrete blocks with steel bars at the centre were then cured for 28 days continuously in fresh water, which are shown in Figure 2 and 3.

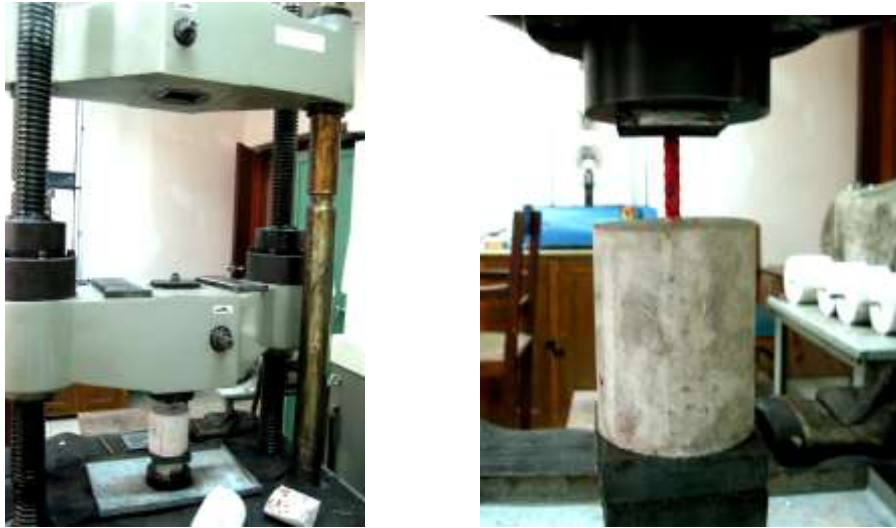
Figure 4. Universal testing machine with special fixture (left) and close-up view of concrete block under test (right).

steel bars and the cured concrete. For testing, a special fixture with a central hole was used (Figure 4), where sample was placed over it and a compressive load was applied from the upper part of the bar to take it out from the bottom level of the concrete block.

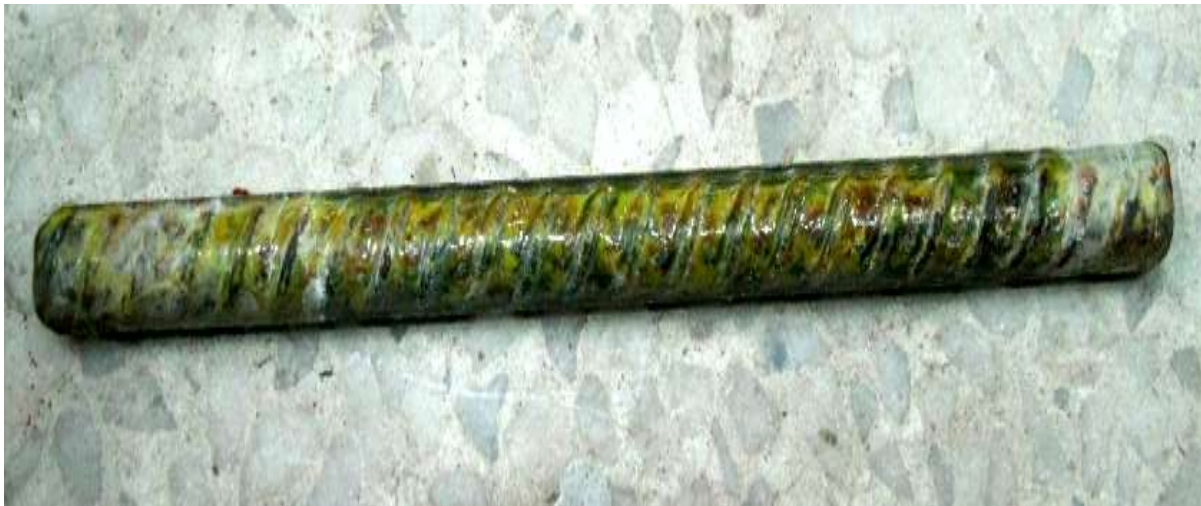
Figure 5. Pulled out epoxy paint coated bar from inside the concrete block.

weakness along the surfaces of the steel bars. From Table 5, it is also clear that epoxy coating is harder than other two paints. Because of higher hardness, when the epoxy coated bar was compressed from upper part to pull out from the concrete bottom, the coating was broken, that caused higher level of interfacial friction. The higher level of pulling friction means more energy absorption to take out the bar from inside the concrete. This caused the coating to be partially broken, especially from the bar ribs, which is clear from Figures 5 and 6.

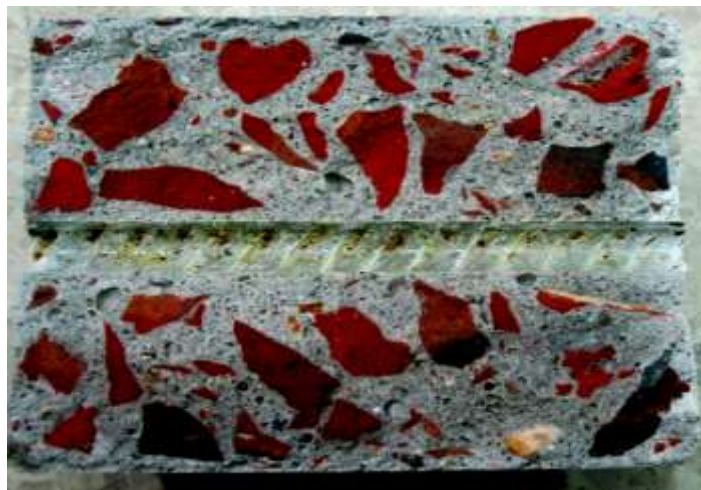
Figure 6. Broken epoxy paint coating from the pulled out steel bars.

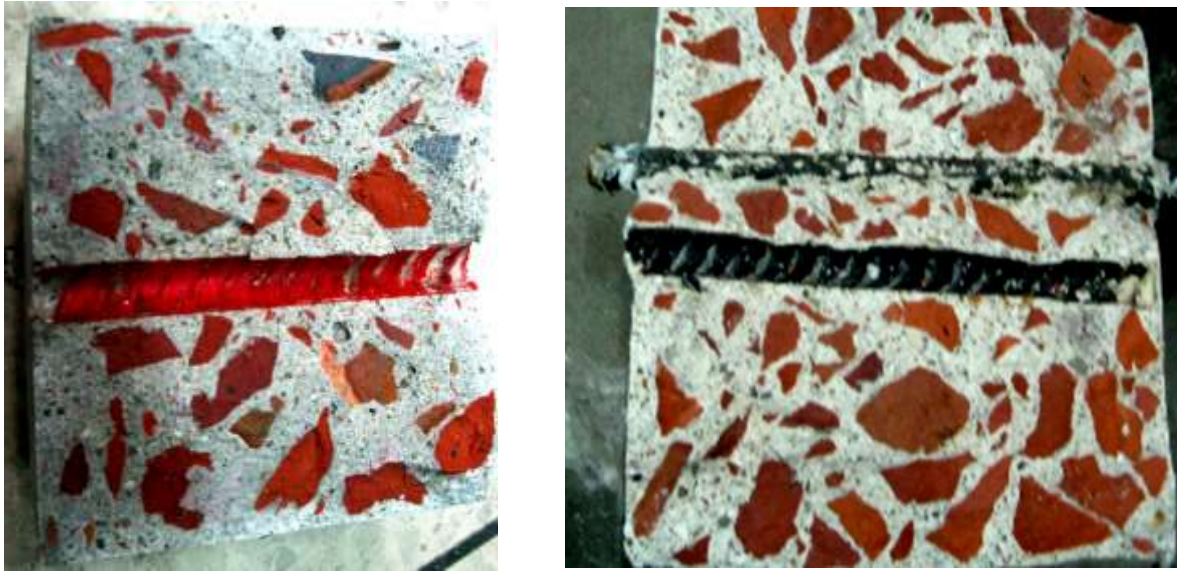
Figure 7. Retained enamel (left) and ujala paint coating layers on the bar-concrete interfaces.

However, for steel bars with other two polymeric paints, the coatings were remained almost fully attached on the concrete-steel bar mating surfaces,

Figure 7. This means the bonding between paints and the steel bar was not sufficiently strong.
