## Analysis of Shoreline Change and the Problem of Saltwater Intrusion: A Case Study on Sagar Island and its South-Eastern Part, West Bengal, India

**Keywords:** Coastal erosion; Sagar Island; Boatkhali; Embankment; Saltwater intrusion.

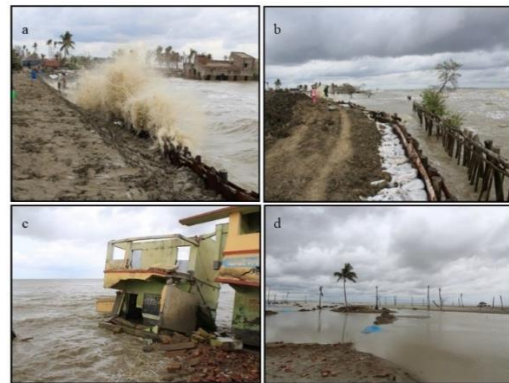
**Plate 1. Coastal Erosion in Sagar Island- a: Incoming of high energy waves; b: Breached embankment near Boatkhali; c: Destruction of a school building due to coastal erosion; d: Degradation of mangroves and other vegetation.**

- Severe bank erosion in the north and south-eastern parts of the island.
- Wave erosion in the south-eastern and south-western part of the island.
- High flood velocity during the onset of monsoon every year.
- Tidal bulge results in high wave energy and action accelerates the process of erosion along the coast.
- Impact of severe tropical cyclone eg. Cyclone Aila in May 2009.
- Climate change induced local sea level rise.
- Submergence and increased wave attack due to storm surges.
- Erosion of marginal embankment along the reclaimed area.
- Degradation of mangrove forest species taking place along the coast accelerating the process of coastal erosion.
- Human activities along the on-shore and off-shore section of the coast.

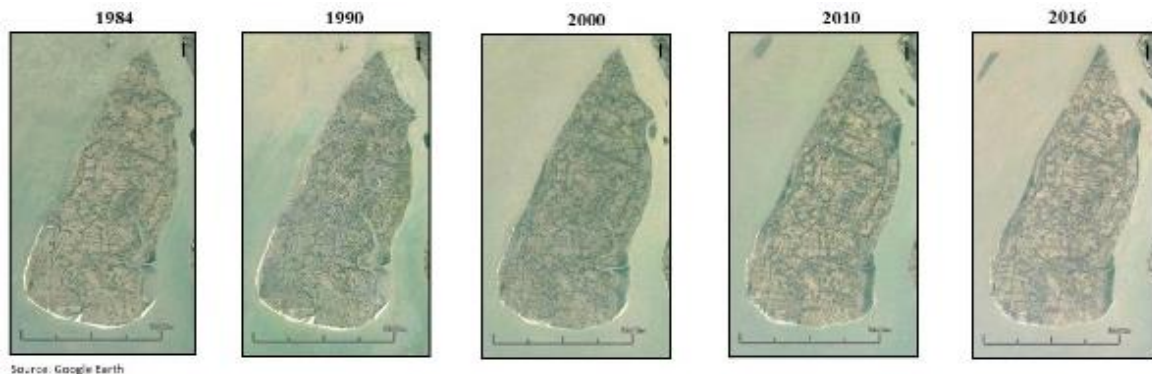
**Fig.2. Change in the Configuration of Sagar Island**

With the help of Google Earth, five images of Sagar Island for the years 1984, 1990, 2000, 2010 and 2016 have been analysed for depicting the change in the configuration of the island. It is observed that the size of the island increases in 2016. In 2000, a small part of a broken island is attached to the north-eastern part of the Sagar Island. It is found that in 2016 the area under mangrove also increases in the south-eastern part of the island which is now under the threat of further degradation. Due to the breaching of the embankment, the problem of coastal erosion is increasing in the southern part of the island [17]. The northern peak of the island is now under the influence of accretion and naturally growing mangroves. It indicates that both the processes of erosion and accretion are working together around Sagar Island.

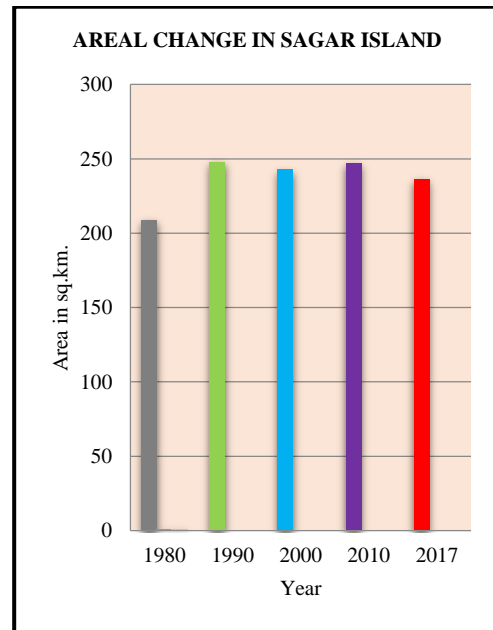
Fig.4. Areal Change in Sagar Island (1980-2017)

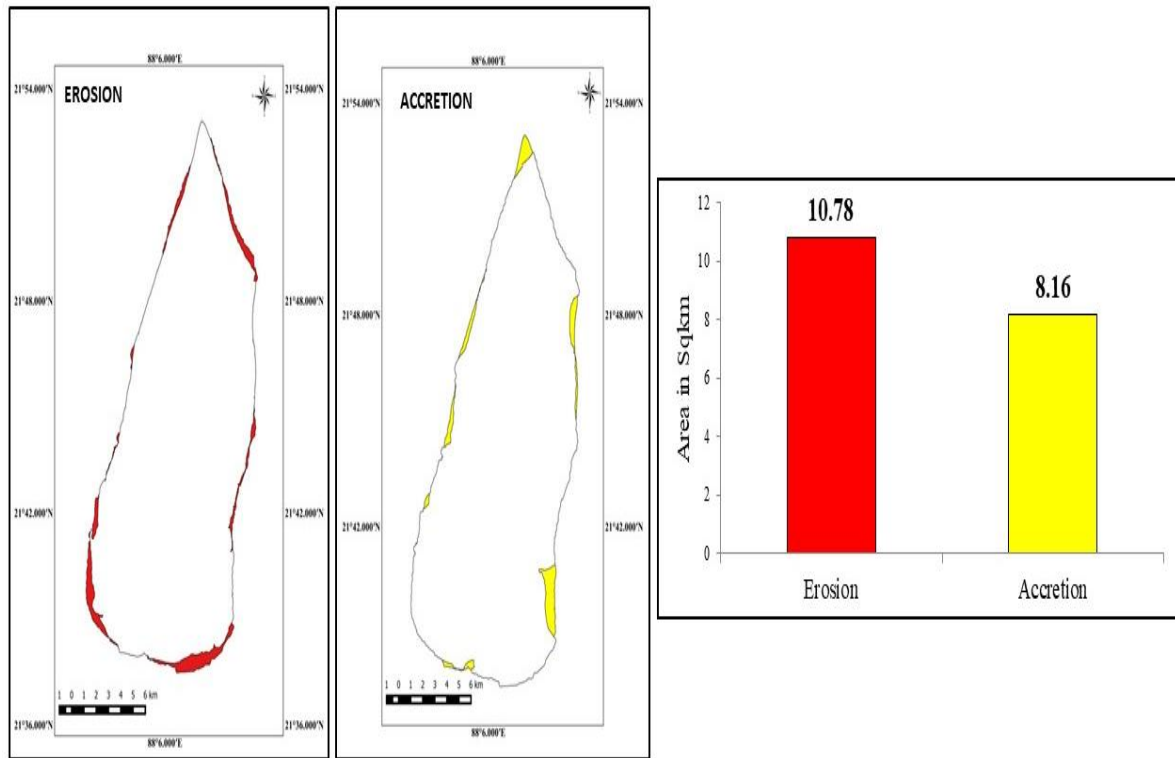
Fig.6. Areal Change in Sagar Island (Erosion-Accretion)

areal change in Sagar Island, we have taken the satellite images of 1980 and 2017. It is found that due to the breaching of the embankment, the problem of coastal erosion is increasing in the southern part of the island. The northern peak of the island is now under the influence of accretion and naturally growing mangroves. It can be observed from the chart that the total amount of eroded land is 10.78 sq.km. whereas the total amount of deposited land is 8.16 sq.km. It indicates that both the processes of erosion and accretion are working together around Sagar Island.

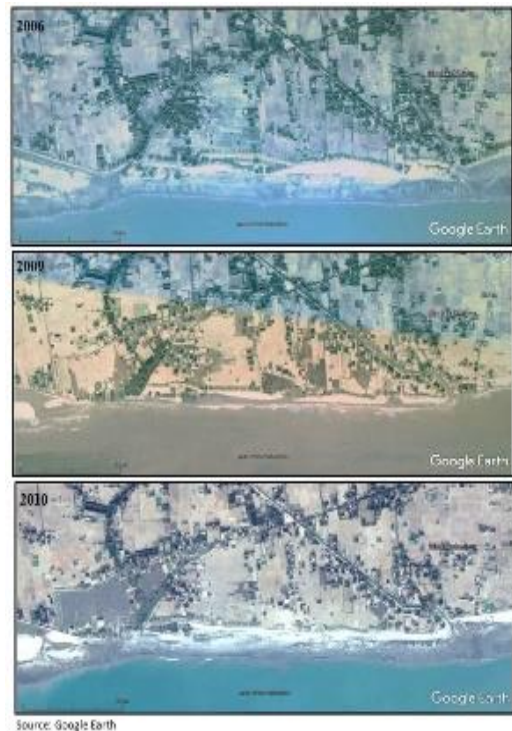
Fig.7. Landscape Change in Boatkhali region (2006 to 2010)

For analysing the change in the landscape over the years around the Boatkhali region in the south-eastern part of Sagar Island we have taken Google Earth images for the following years- 2006, 2009, 2010, 2013, 2014 and 2015. From the first three images of 2006, 2009 and 2010, it can be observed that most of the land is agricultural area. But with time the breaching of the embankment near the coast results in saltwater intrusion in the Boatkhali region. The previously fertile lands were converted into fishing grounds for the establishment of aquaculture farms. From the next three images of 2013, 2014 and 2015 it can be observed that most of the area is now dedicated to aquaculture farms. Due to the nearness of the farms with high tide line the salinity ranges are high in these areas. The number of settlements has also increased with time. The vegetation land is also found increased over the years.

From the images, it is indicated that over the years the coastline has been shifted inland. The coast comes under the zone of diurnal tidal cycle. The impact of both high tide and low tide results in the mixing of freshwater with the saline water of the sea. During the highest high tide, the saline water reaches the inland resulting saltwater intrusion in the village. Due to high evaporation rate the rate of salt concentration on the surface increases. The salinity is high mainly in the areas near to the high tide line. Away from the coast, the salinity range becomes low. In further inland, in the agricultural lands, the salinity is found to be minimum.

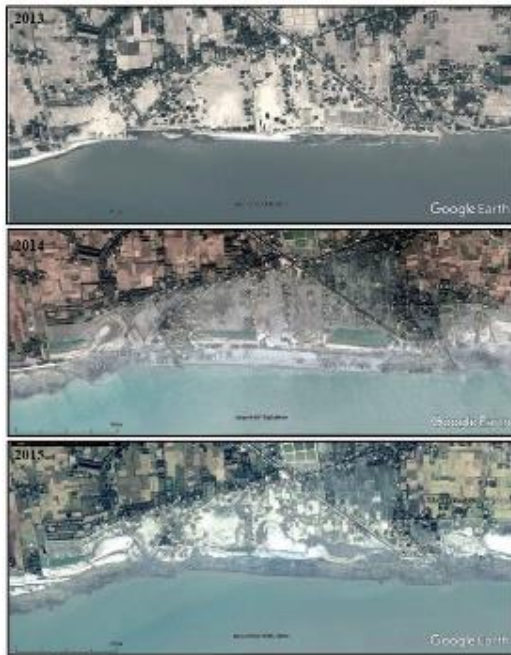
Source: Google Earth  
**Fig.8. Landscape Change in Boatkhal region (2013 to 2015)**

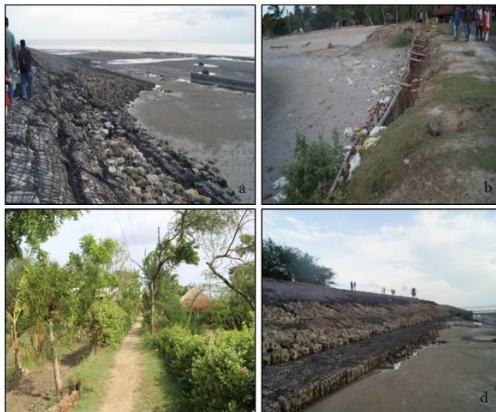
Plate 2. Some suggested measures- a: Net Fencing; b: Revetment; c: Afforestation; d: Sea Wall

- Coastal buffers i.e. mangroves area should be strictly protected from the intervention of people.
- Defense of the coastal land should be encouraged by providing beach nourishment.
- Awareness among the people of the affected areas about the protective and ecosystem function of the mangroves.
- Repairing of the brick-paved embankment along with the revetment. Post-monsoon is the best time for building the breached embankment.
