# Damage Testing Of Civil Engineering Structures by Vibration Monitoring

## SUMMARY

## THE CASE STUDY: A STEEL-CONCRETE COMPOSITE MR FRAME STRUCTURE

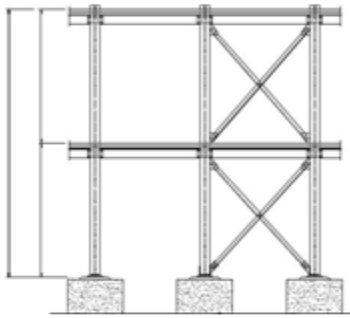
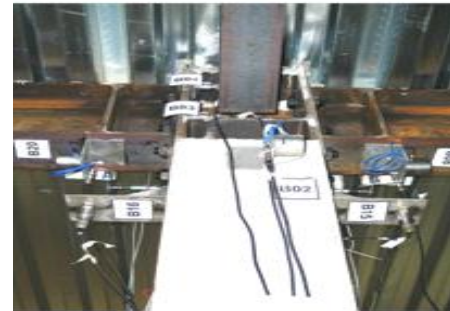
Fig: Instrument configuration of an interior beam-to-column joint

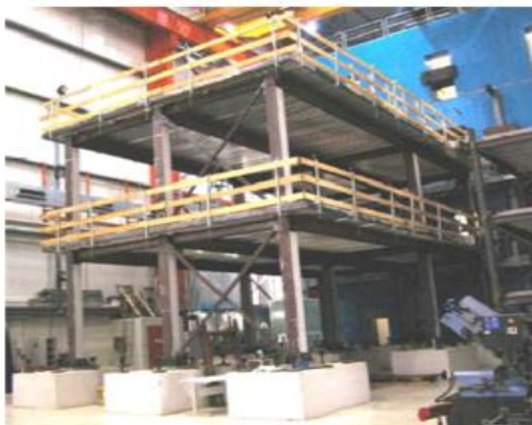
Fig. 5. Front-side picture of the test structure

Partial-strength beam-to-column joints have been designed to provide a joint rotation of 35 mrad associated to a residual strength of at least 80 % of the maximum strength. A sketch of the specimen and a joint detail are shown in fig. 5 and 6, respectively. Similar performances have to be guaranteed by base joints, composed by a thick extended plate welded to the columns and connected to the reinforced concrete foundation blocks by hooked rebars threaded at the upper end. The gap between the plate and the foundation has been filled with grout. A complete description of the structure and utilized materials can be found in [24].

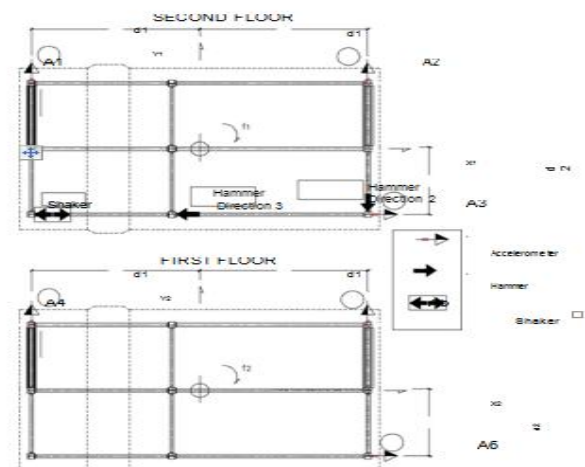
Fig. 7. Location of shaker, hammer impact points and accelerometers at the a) top storey and b) bottom storey

An impact force was applied by striking the protruding part of the columns A2 and A3, see fig. 3, above the top storey in the Shock Hammer Test (SHT). An instrumented sledge-hammer PCB 086D50 characterized by a total mass of 10.77 kg was employed; the direction of forces is indicated in fig. 7.

i) a global configuration A aimed at describing the overall dynamic behaviour of the structure conceived as a system with two translational DoFs and one rotational DoF per storey. The assumption of rigid floor deck and inextensible columns was implicitly assumed. A total of 6 accelerometers labelled A0 - A6 were utilized, three per floor, as shown in fig. 7.

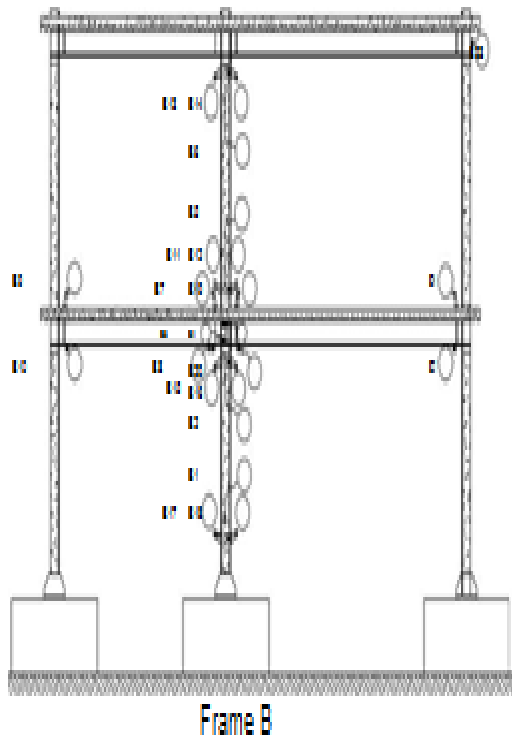
Fig. 8. Location of accelerometers in the configuration B for the interior joint

ii) two local configurations B and C investigated the behaviour both of interior and exterior first floor joints at the interior frame. A maximum of 23 accelerometers was utilized, labelled B1 - B23 for the interior joint as illustrated in fig. 8; while 22 accelerometers, labelled C1 - C22 were installed on the exterior joint, as depicted in fig. 9. A detailed representation of the instrument configurations is reported in fig. 12a) and 12b) for interior and exterior joint, respectively.

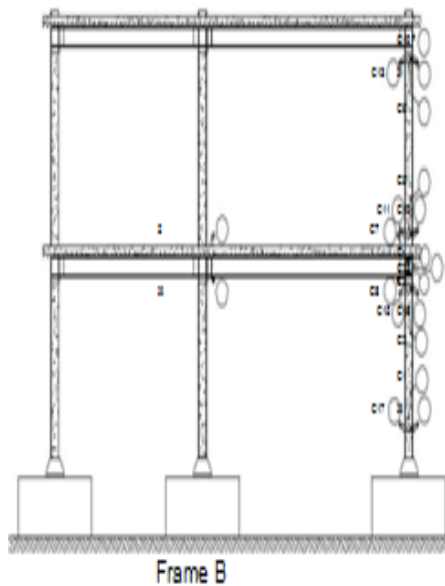
Fig. 9. Location of accelerometers in the configuration B for the exterior joint

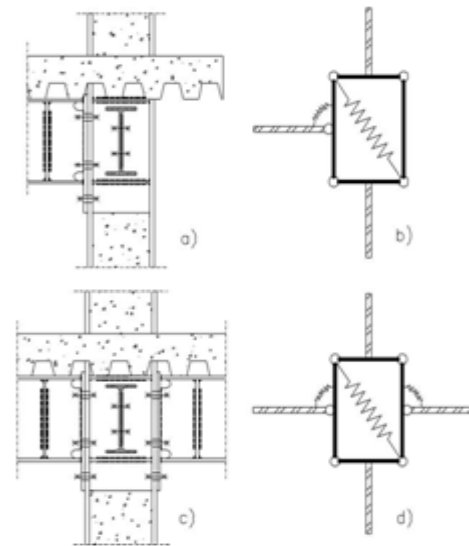
Fig. 10. Joint models (b, d) for the exterior (a) and interior (c) joint.

The location of accelerometers derives from a mechanical model, presented in fig. 10b and 10d for interior and exterior joints, respectively. The model consists of a mechanical idealization which involves 4 rigid bars connected together by pins with translational and rotational springs. The translational spring simulates the stiffness of the column web panel under shearing; while two rotational springs represent the flexural stiffness of beam-to-column connections. The stiffness of the connection between columns and foundations has also been modelled via rotational springs.

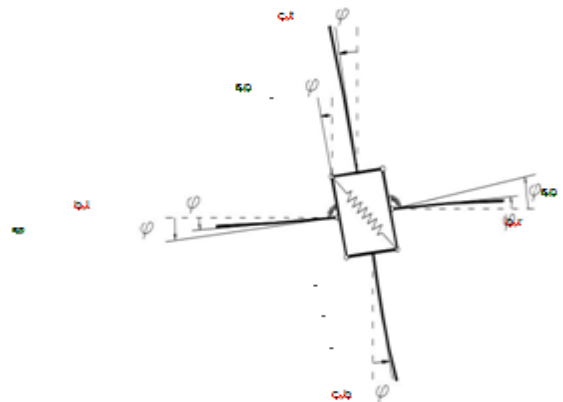
Fig. 11. Kinematic quantities relevant to an interior joint.

Fig. 11 shows kinematic quantities needed to characterise the joint behaviour. In detail, we can indicate  $\phi_{sp}$  as panel rotation;  $\phi_{c,t}$  and  $\phi_{c,b}$  as end

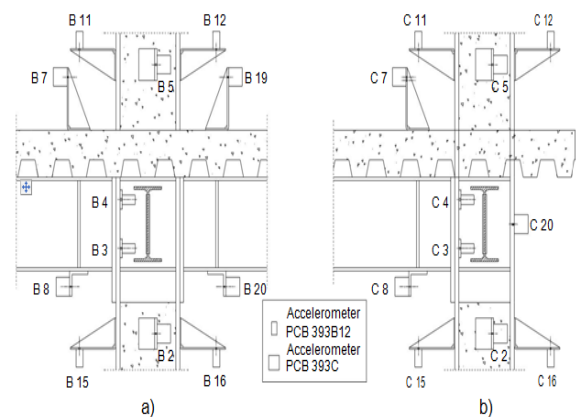
Fig. 12. Accelerometer lay-out: a) configuration B for the interior joint; b) configuration C for exterior joint.

for the panel distortion and the right connection rotation, respectively. Accelerometers have been arranged both on interior and exterior joints as illustrated in fig. 12a) and 12b), respectively. Kinematic quantities  $\gamma_{sp}$ ,  $\phi_{conn,l}$  and  $\phi_{conn,r}$  can be evaluated by means of simple relationships and modal analysis.

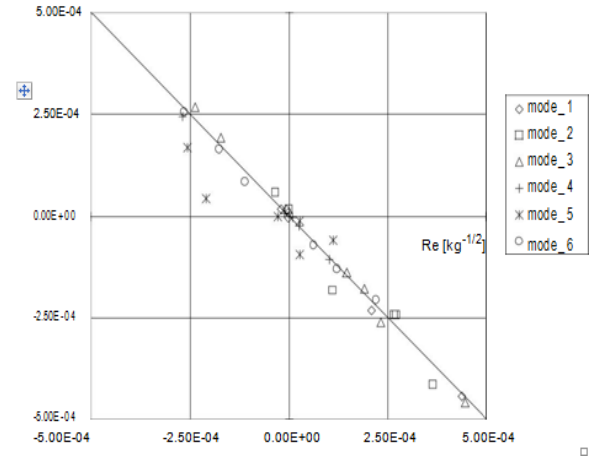
Fig. 13. Complex plan representation of the first six mode shapes in phase I, normalized with respect to the mass matrix.

In order to verify usual assumptions regarding damping ratios employed in frame structures, a non-proportional viscous model was adopted in analyses as it is more general compared to the Rayleigh's model. Extracted complex values of modal shapes relevant to the A configuration result to be approximately arranged along a straight line inclined to  $-45^\circ$  shown in fig. 13. This property assure that damping can be considered of proportional type in phase I [22, 30]. Therefore, it was possible to extract real values of modal shapes like, for instance, the first, second, third and fourth mode of the structure in the undamaged condition represented in fig. 14. These mode shapes correspond respectively to: i) the first flexural mode in the main frame direction; ii) the first flexural mode in the orthogonal direction; iii) the first torsional mode; iv) the second flexural mode in the main frame direction. Moreover, the fifth and sixth mode correspond the second flexural mode in the orthogonal direction and to the second torsional mode, respectively.

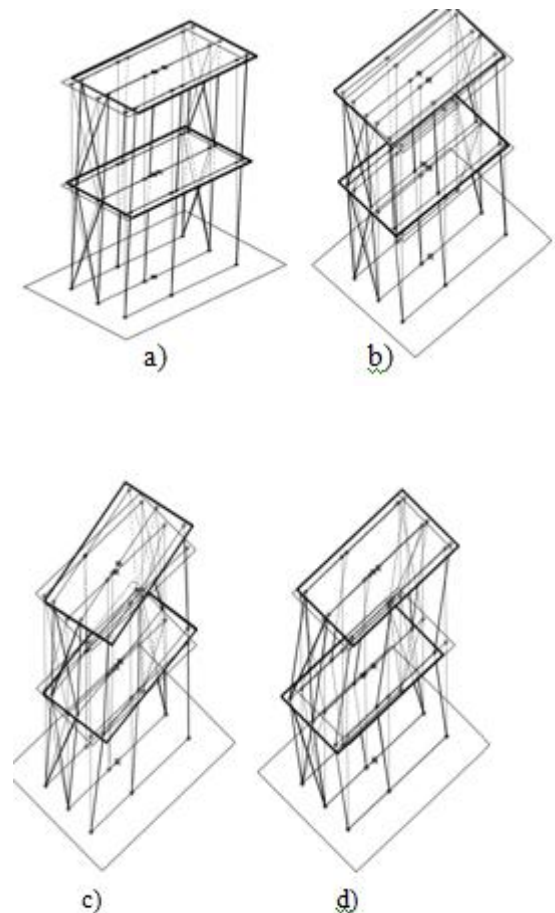
Fig. 14. Mode shapes of the frame structure relevant to phase I: a) first flexural mode in the main frame direction; b) first flexural mode in the orthogonal direction; c) first torsional mode; d) second flexural mode in the main frame direction

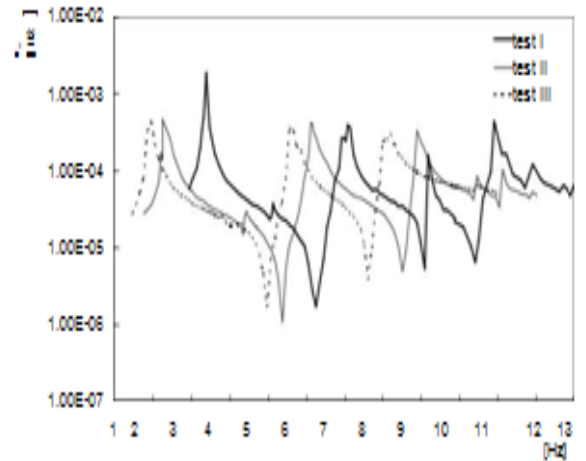
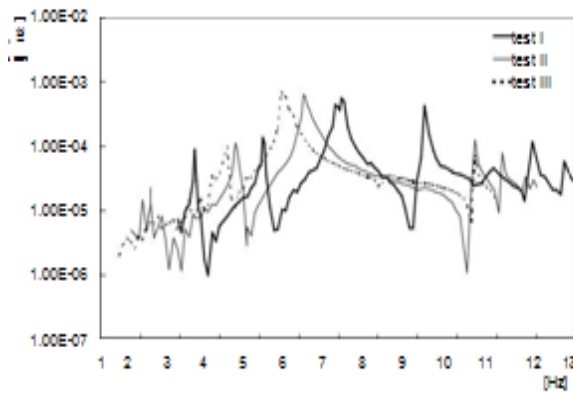
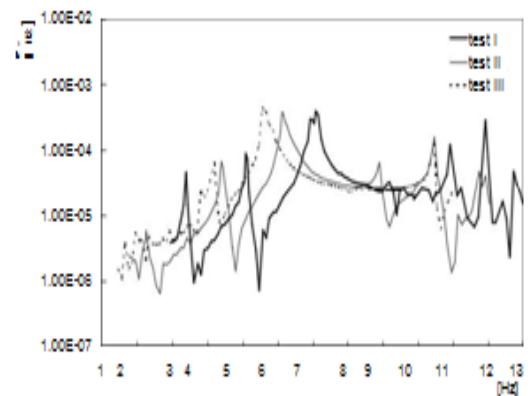
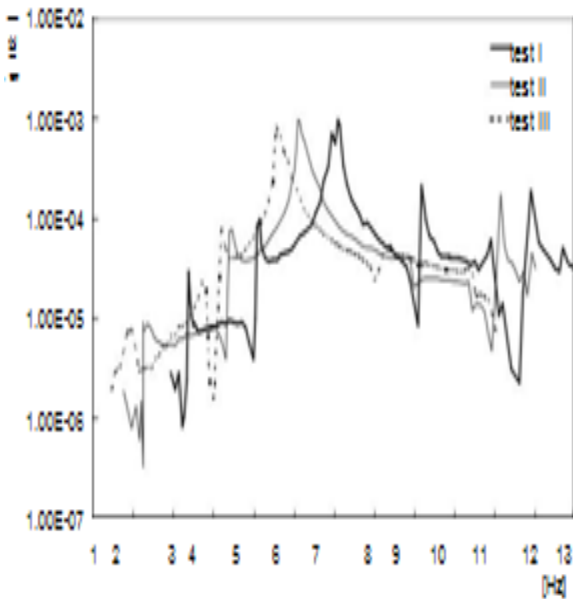
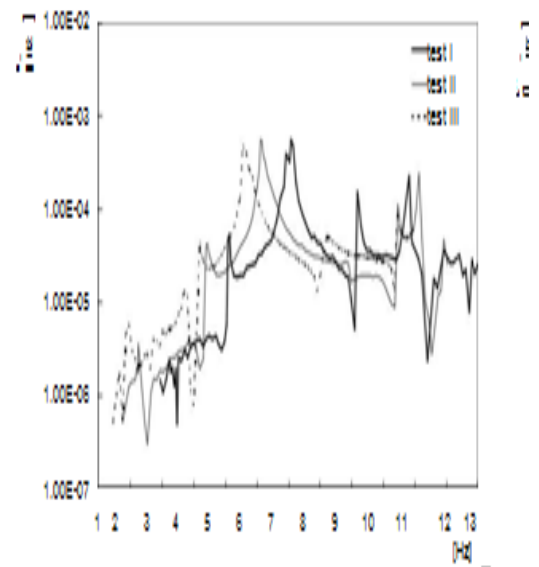
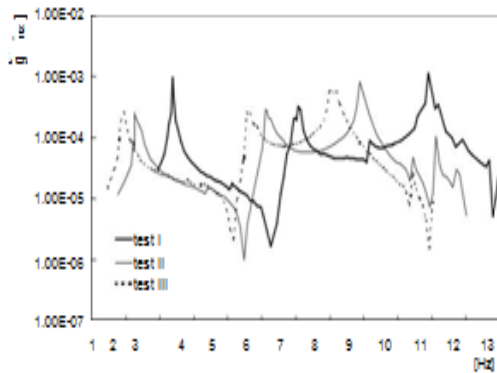
SST FRFR-A3

SST FRF-A1

SST FRF-A4

SST FRF-A2

SST FRF-A5

SST FRF-A6

Fig. 15: FRF obtained from the SST at the maximum force of and III. Accelerometers A1 - A6 of the shaker applied to the structure in test phases I, II the global A configuration.

The results of dynamic tests carried out in the three phases of the structure life allow preliminary information on the damage undergone by the structure owing to PsD and cyclic tests to be acquired. A qualitative comparison between FRFs is reported in fig. 15. It shows that moving from the undamaged to the medium and strongly damaged phases, a substantial shift of resonance peaks towards the lower frequencies zone happened. A detailed analysis of the identified natural frequency values, reported in table 3, shows that a general reduction of the natural frequencies has occurred: this phenomenon appears particularly pronounced for the flexural modes in the main frame direction, i.e. for modes 1 and 4. A reduction of nearly 40% between the undamaged and the strongly damaged state, e.g. between test I and III for the first frequency has been observed.

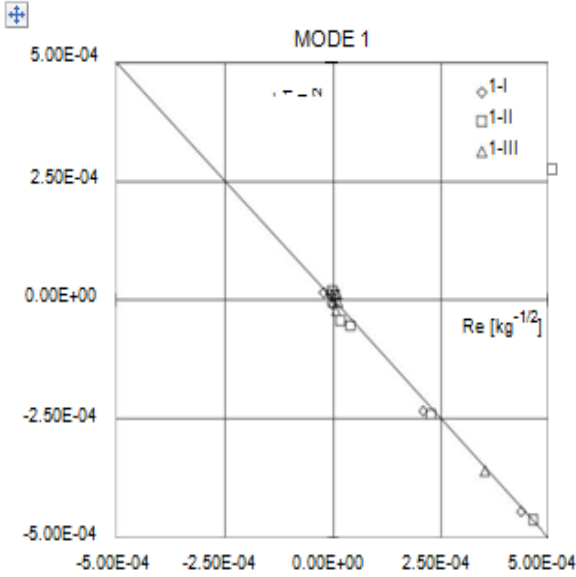
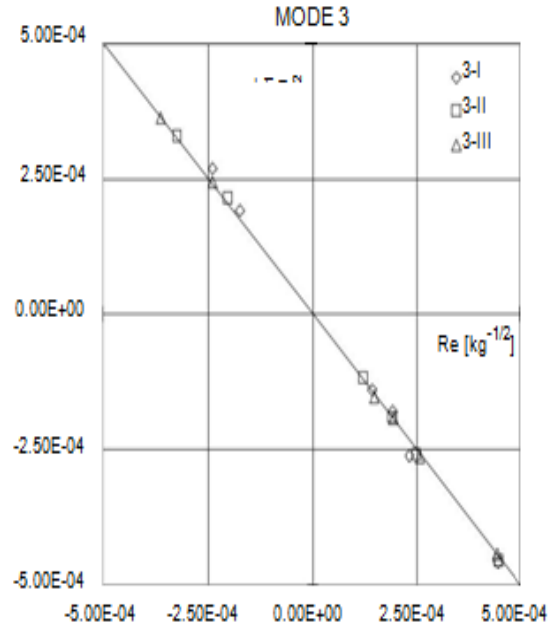
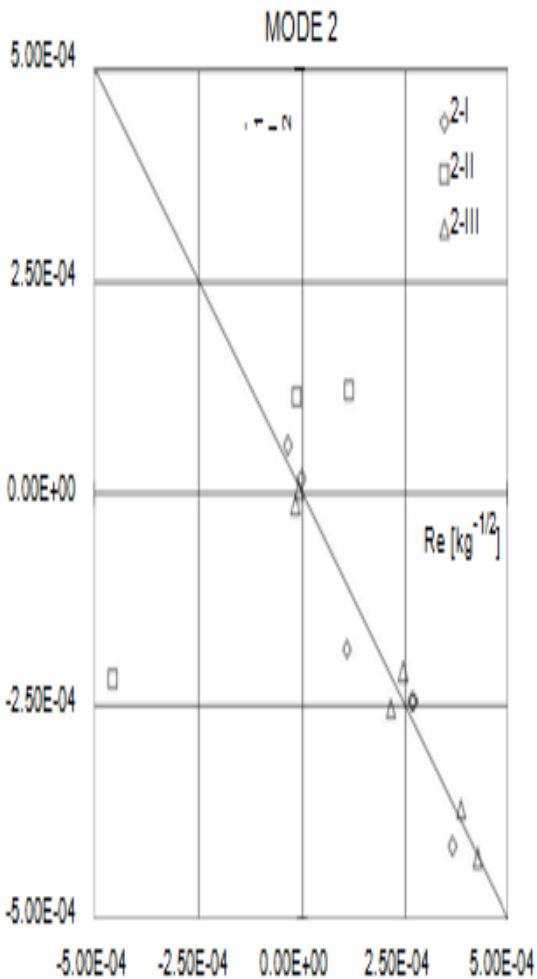
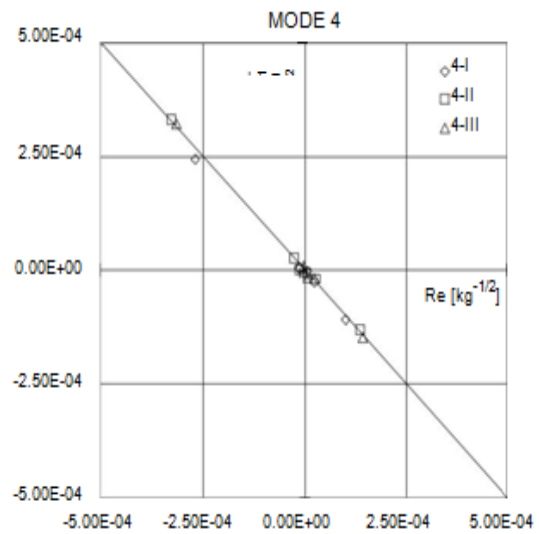
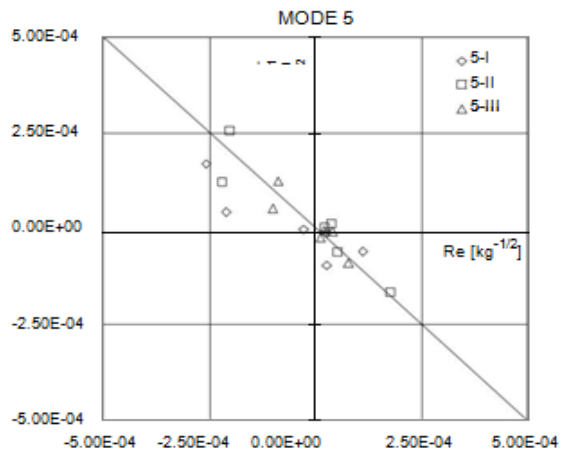
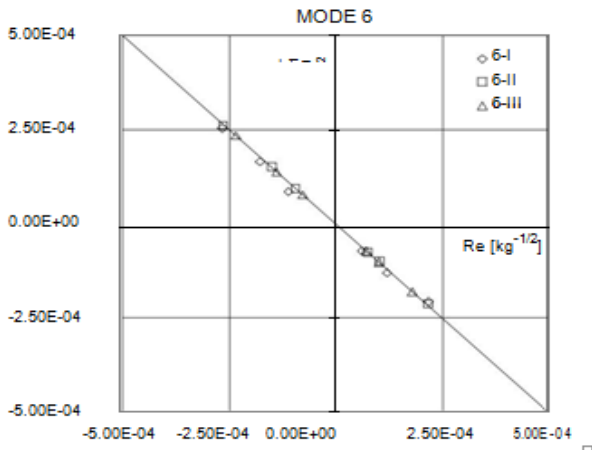
Fig. 16. Comparison of first six mode shapes identified in tests I, II and III.

Tables 4, 5 and 6 reports the values of the MAC index obtained from the comparison of modes extracted in tests I and II, I and III and II and III, respectively. An attentive reader can observe that correlations between the modal shapes identified in the three phases are generally good as diagonal terms of the MAC matrices assume values greater than 0.9 for nearly all modes [31]. The representation on the complex plan of single modes identified in the three phases, and reported in fig. 14, shows that nearly all modal shapes lie along a straight line inclined of  $-45^\circ$ ; together with the high MAC diagonal coefficients. This trend indicates that, contrarily to resonance frequencies, modal shapes do not vary with the damage level.
