Review on Common Failure of Gears

Ram Kumar Kunjam

Student, Mechanical Engineering, Kirodimal Institute of Technology Raigarh (C.G.) ramkunjam@gmail.com

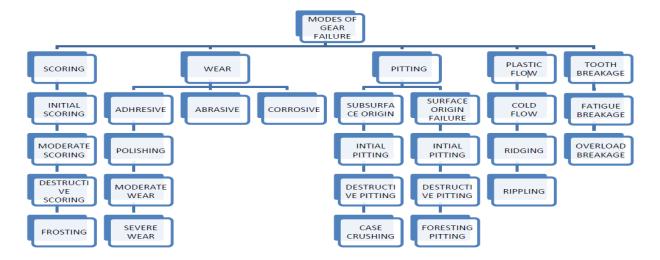
Fig. 1 Different modes of failure

The characteristics of these various gear types are discussed in most mechanical design texts like all mechanical components, gears can and do fail in service for a variety of reasons. In most cases, except for an increase in noise level and vibration, total gear failure is often the first and only indication of a problem. Many modes of gear failure have been identified, for example fatigue, impact, wear or plastic deformation. Of these, one of the most common causes of gear failure is tooth bending fatigue. Fatigue is the most common failure in gearing. Tooth bending fatigue and surface contact fatigue are two of the most common modes of fatigue failure in gear. Several causes of fatigue failure have been identified. These include poor design of the gear set, incorrect assembly or misalignment of the gear, overloads, inadvertent stress raisers of subsurface defects in critical areas, and the use of incorrect materials and heat treatments A gear is a rotating machine part having cut teeth. which is meshing the gear teeth to transmit the torque. A geared device can be change the speed, direction of power sources and magnitude[2]. The tooth meshing on another gear of non rotating parts is called rack. when it a rotation it provide transmission in analogous to the wheels in pulley. It is the cylindrical shaped its teeth are parallel in axis. its wide range of application most commonly used[3]. Gear failure can occur in various modes. In this chapter details of failure are given. If care is taken during the design stage it to prevent each of these failures a sound gear design can be evolved. The gear failure is explained by means of flow diagram in Fig. 1.

Gear failure can occur in various modes. In this paper details of failure are given. If care is taken during the design stage itself to prevent each of these failure a sound gear design can be evolved. The gear failure is explained by means of flow diagram in Fig. 1.
